21st Century Home Inspections LLC.

Page 1 of 12
Raised Sample Pictures.alb5

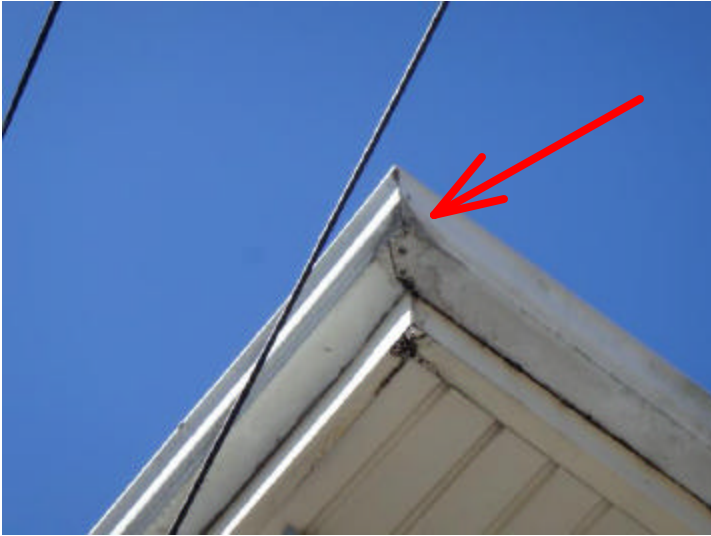
A few of the joints at the gutter runs are leaking.

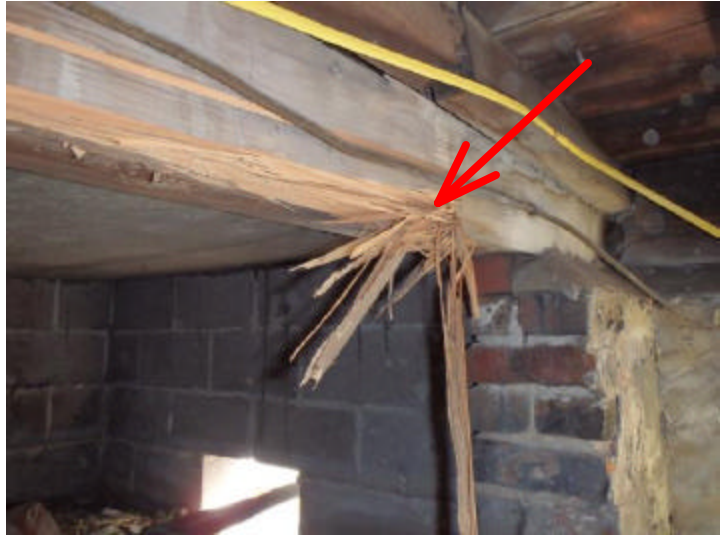
Damages were noted to the front foundation sill. This deteriorated foundation sill should be replaced to ensure it's structural integrity.

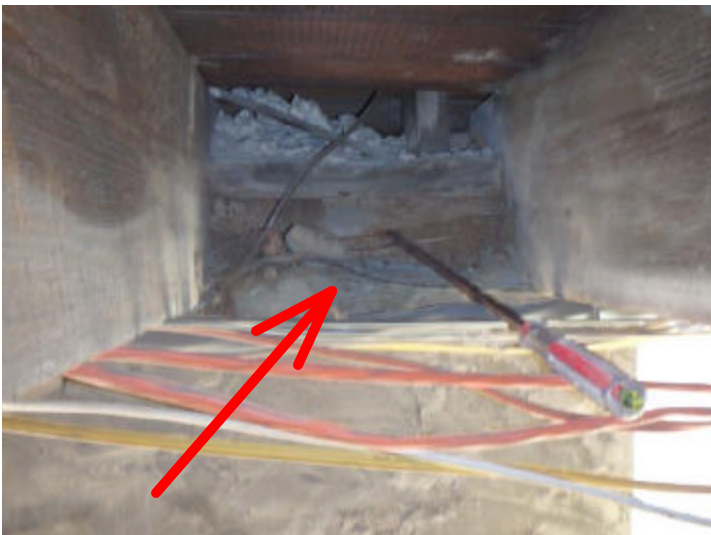
Damages were noted to the foundation sill over the 2nd pier on the left. This deteriorated foundation sill should be replaced to ensure it's structural integrity.

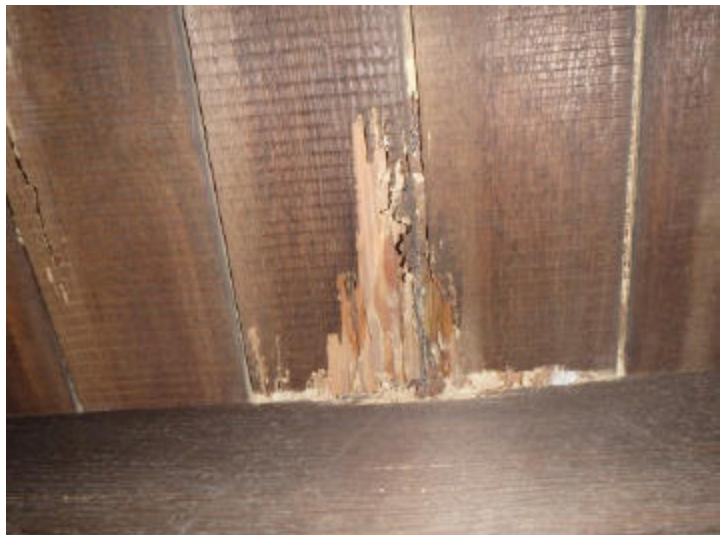
Damages were noted to the tops of the floor joists and to the floor boards in front of the first chimney in the crawlspace, which causes the floors to be loose. The tops of the floor joists can be sistered and the floor boards re-nailed to properly secure them.

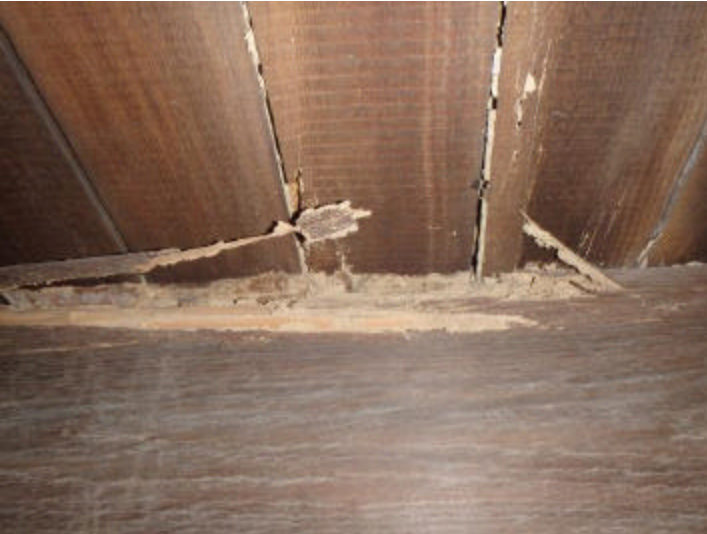
Damages were noted to the tops of the floor joists and to the floor boards in front of the first chimney in the crawlspace, which causes the floors to be loose. The tops of the floor joists can be sistered and the floor boards re-nailed to properly secure them.

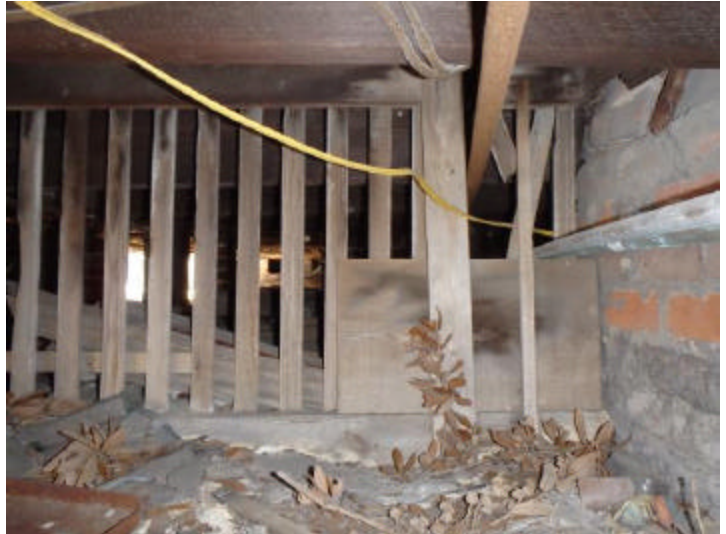
Wood to ground contact was noted at the lattice panel in the middle of the crawlspace. This condition can promote termite infestations.

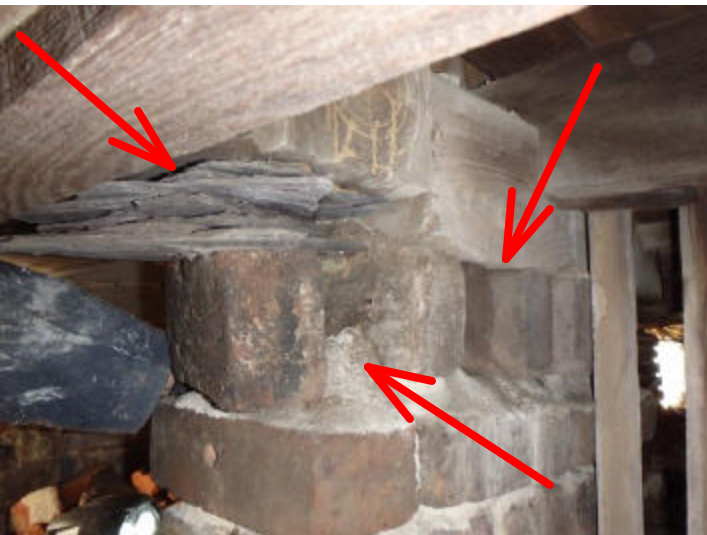
A few loose or missing bricks, which should be replaced, were noted at the foundation pier to the left of the 2nd chimney foundation. These bricks should be replaced and secured for proper support of the foundation sills.

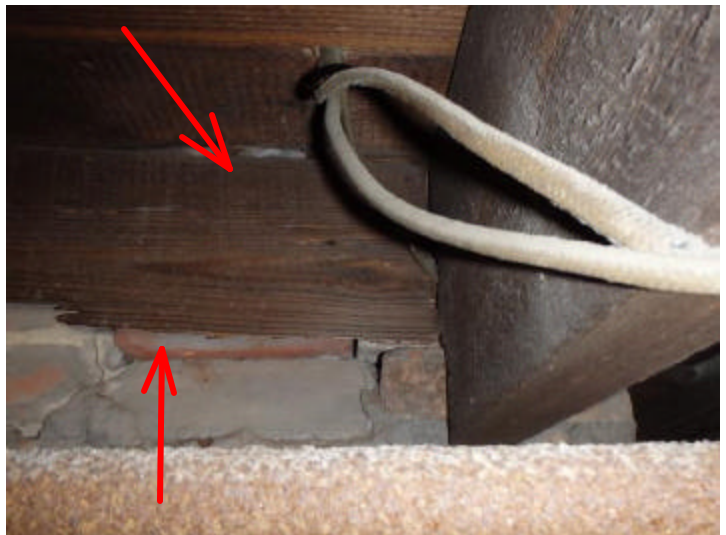
Damages were noted to the blocking at the 2nd chimney foundation. This condition has caused a couple of the floor joists to loosen. These joists should be properly secured to ensure their structural integrity.

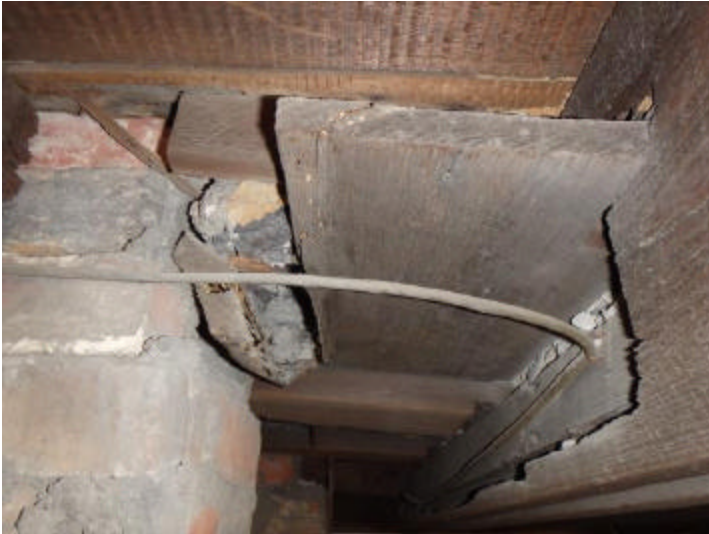
Damages were noted to the blocking at the 2nd chimney foundation. This condition has caused a couple of the floor joists to loosen. These joists should be properly secured to ensure their structural integrity.

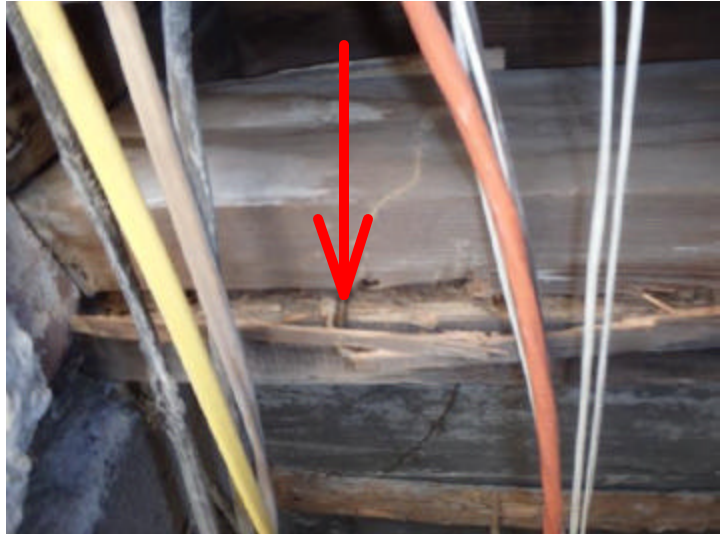
Damages were noted to the cross sill located by the pier to the left side of the 2nd chimney foundation. This deteriorated foundation sill should be replaced to ensure it's structural integrity.

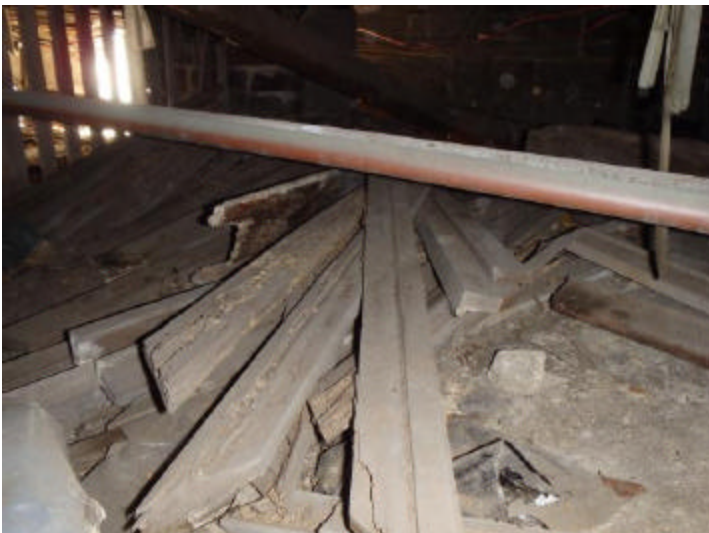
Debris was noted in the crawlspace. This debris should be removed to prevent possible termite infestations and to safely crawl for inspections and service work.

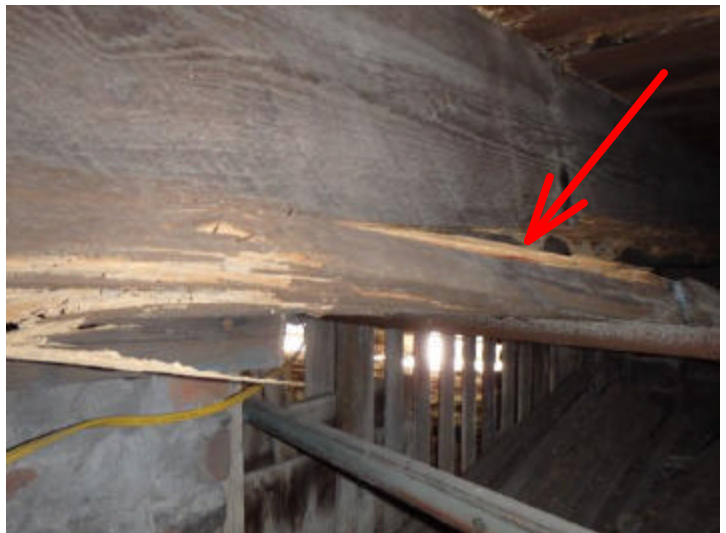
We noted a broken floor joist behind the 2nd chimney foundation. This broken floor joist should be repaired by sistering another board on side of the broken one to ensure it's structural integrity.

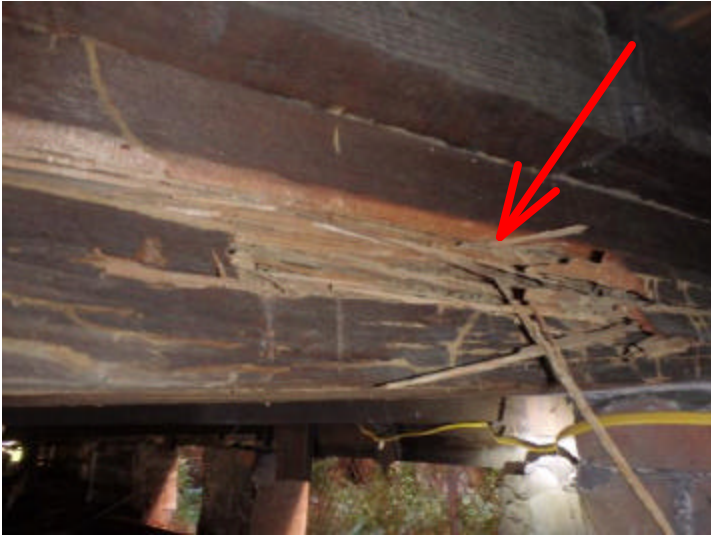
Damages were noted to the right side and cross sill located behind the 2nd chimney foundation by the T- shaped pier to the right. This deteriorated foundation sill should be replaced to ensure it's structural integrity.

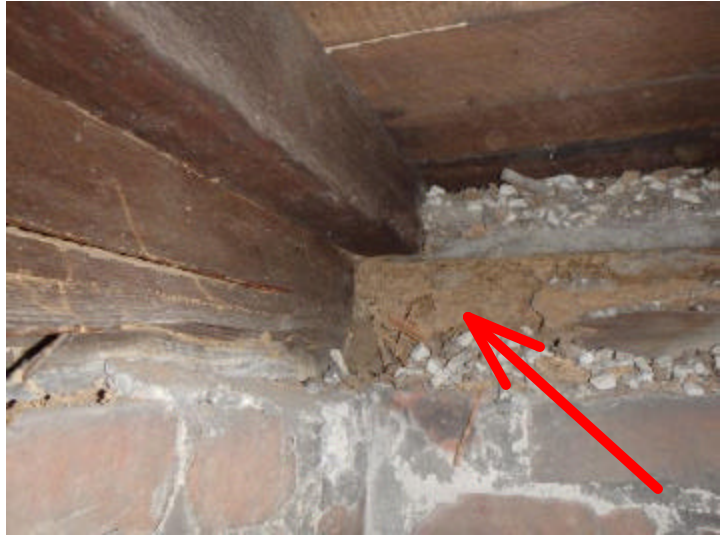
Damages were noted to the right side and cross sill located behind the 2nd chimney foundation by the T- shaped pier to the right. This deteriorated foundation sill should be replaced to ensure it's structural integrity.

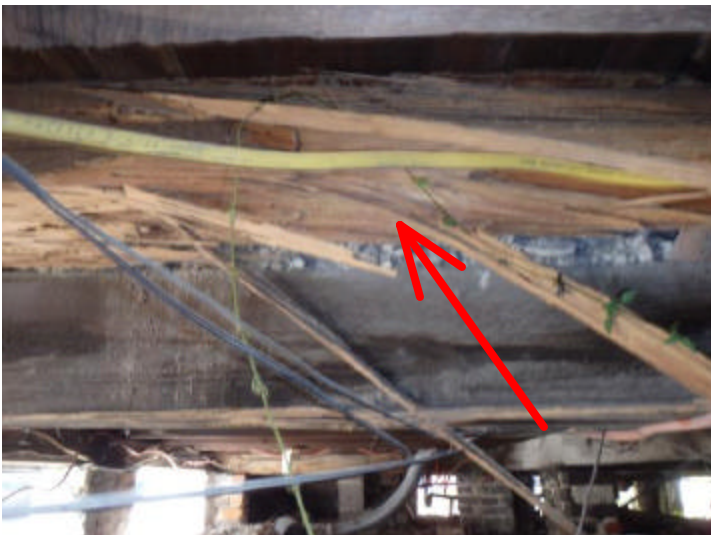
Damages were noted to one of the floor joists to the left of the 2nd cross sill behind the 2nd chimney foundation. This deteriorated floor joist should be repaired by sistering another board on side of the deteriorated one to ensure it's structural integrity.

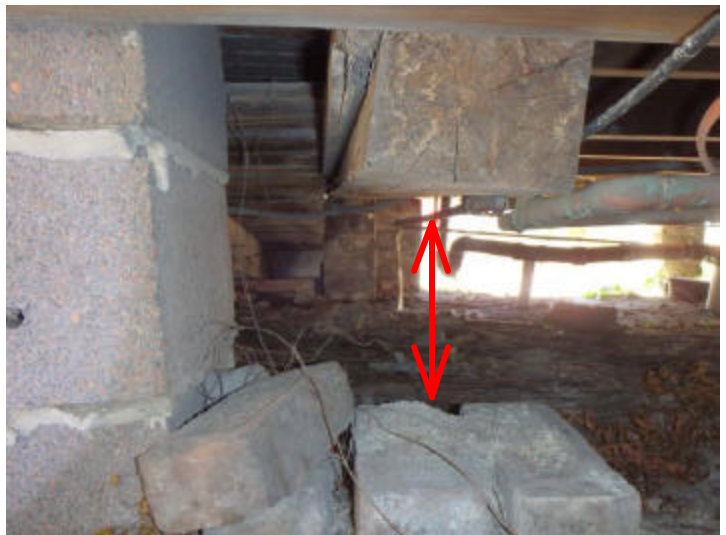
The foundation sill at the left rear porch (which runs from front to back) is hanging, due to a missing foundation pier.

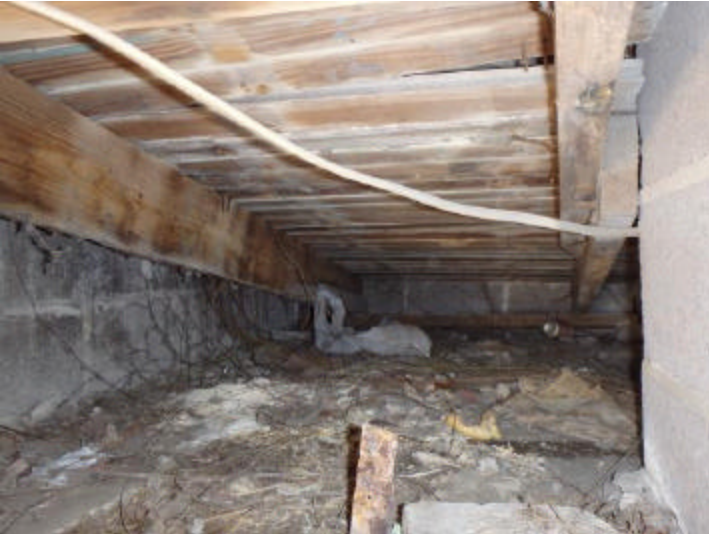
The wood form boards at the front and rear porches can be removed as they are not structural and can promote termite infestations.

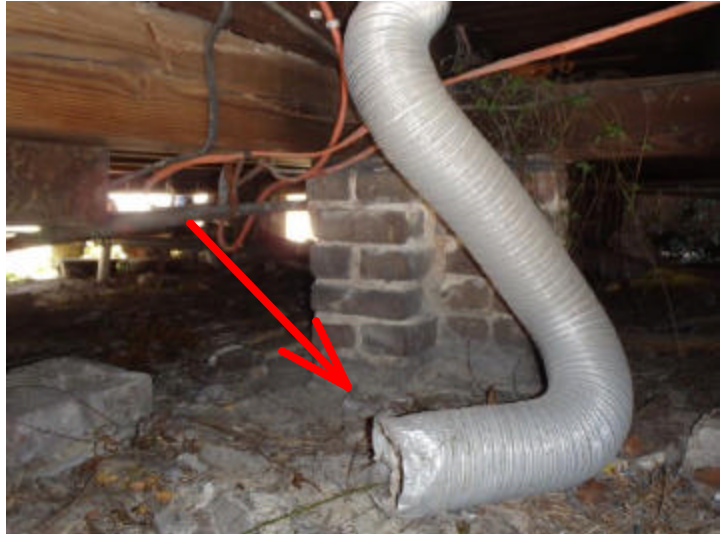
The clothes dryer vents into the crawlspace, which will lead to lint and moisture accumulation. We recommend that the vent pipe be extended to the outside.

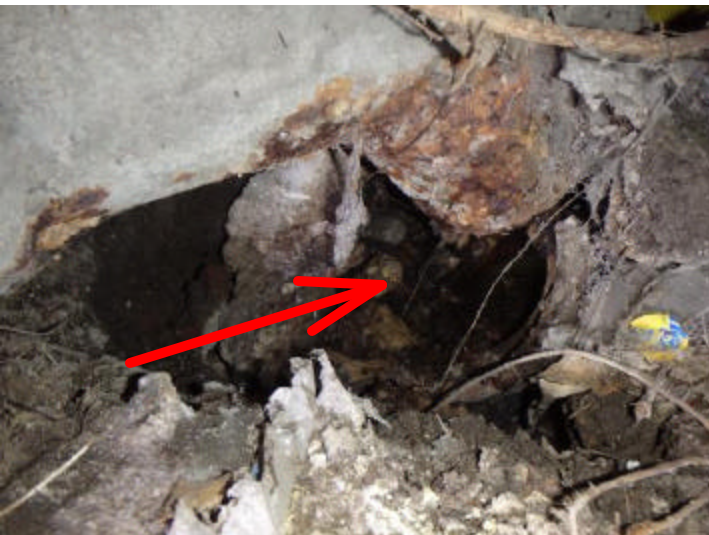
A broken cast iron drain line was noted above ground and underground at the right rear. Please see HyTech Plumbing's separate report for additional details.

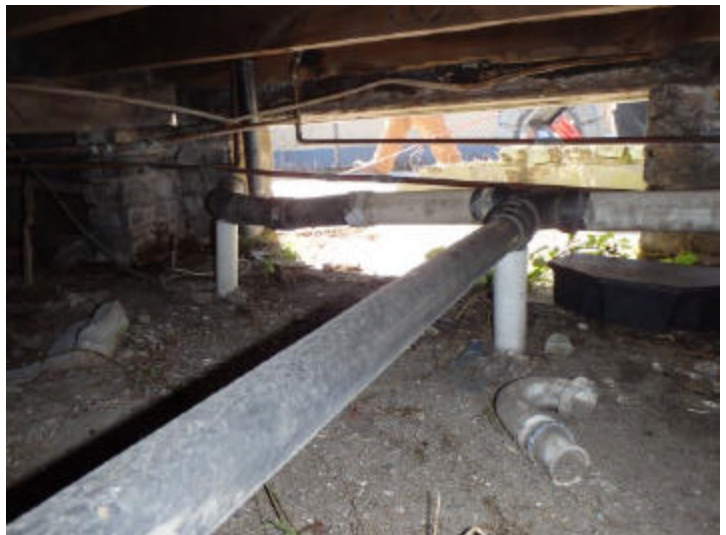
The newer plastic drain lines are improperly supported and are not sloped properly for drainage.

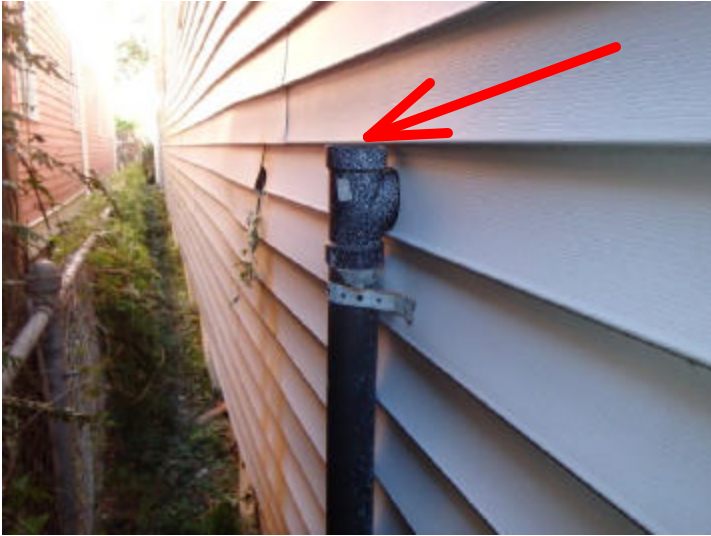
The vent pipe at the right rear should extend above the roof line so that sewer gases can safely escape.

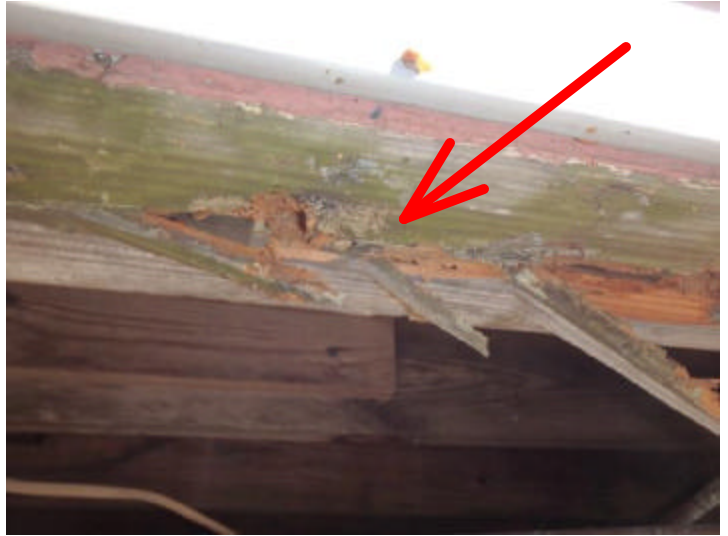
Damages were noted to the rear foundation sill. This deteriorated foundation sill should be replaced to ensure it's structural integrity.

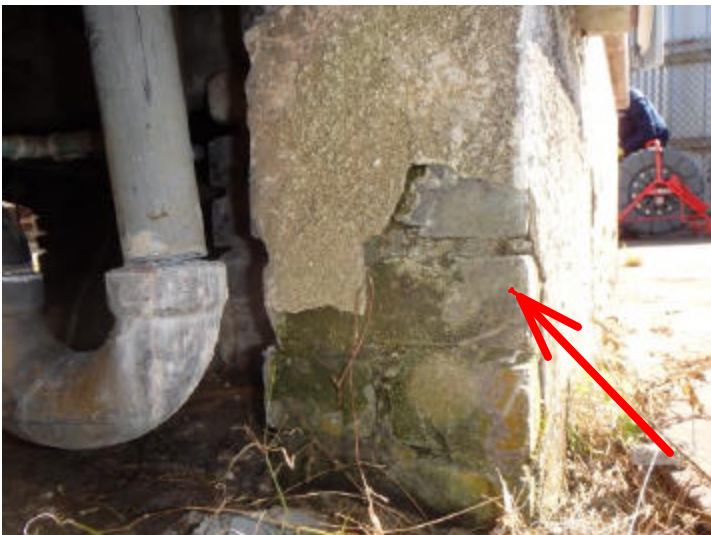
The encapsulation is falling off of some of the piers and can be re-encapsulated (wrapped in a thin coat of cement) to reduce further mortar joint loss.

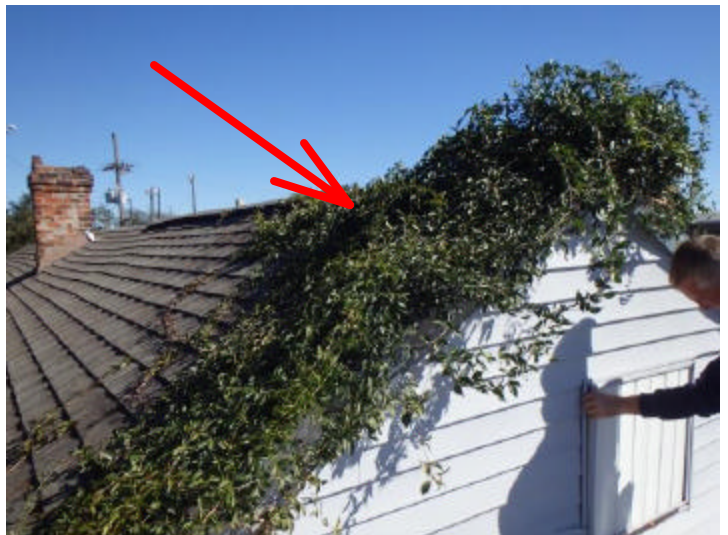
The vines noted on the roof should be removed to minimize damage potential.

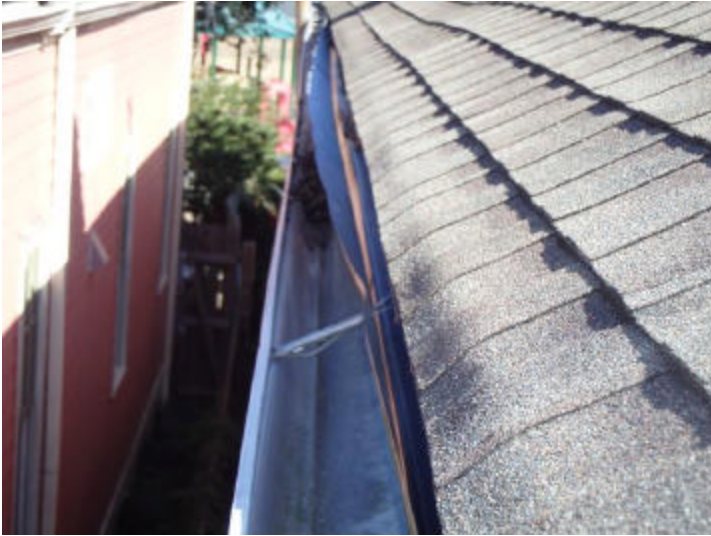
The gutters are falling off of the right side of the house, causing the wood fascia to be exposed.

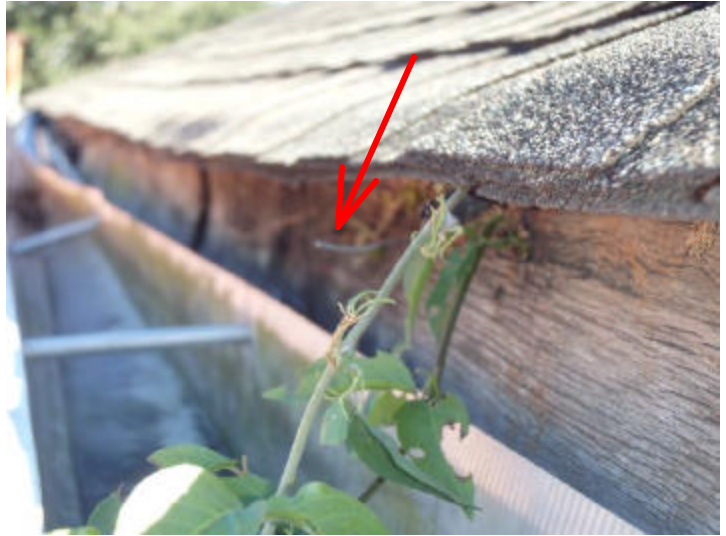
The gutters are falling off of the right side of the house, causing the wood fascia to be exposed.

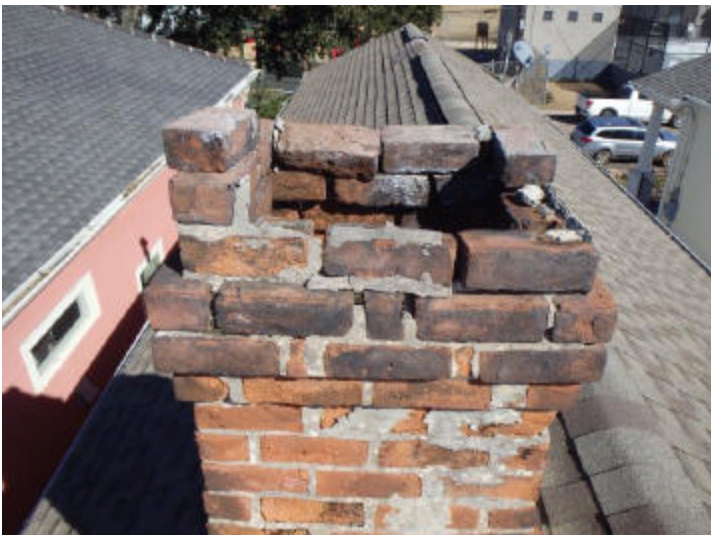
A few loose and missing bricks, which should be replaced, were noted at the chimney on the roof.

A missing rain hat, to prevent rain water from entering the chimney, was noted.

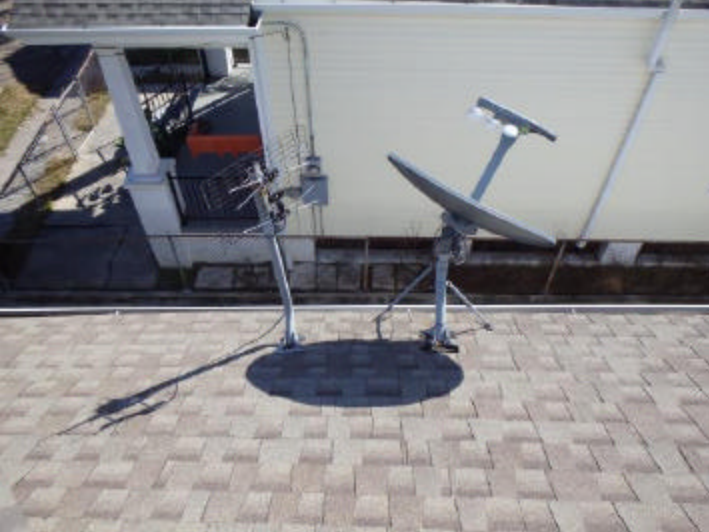
The satellite dish, antennas and brackets on the roof should be removed and the holes sealed to prevent leaks.

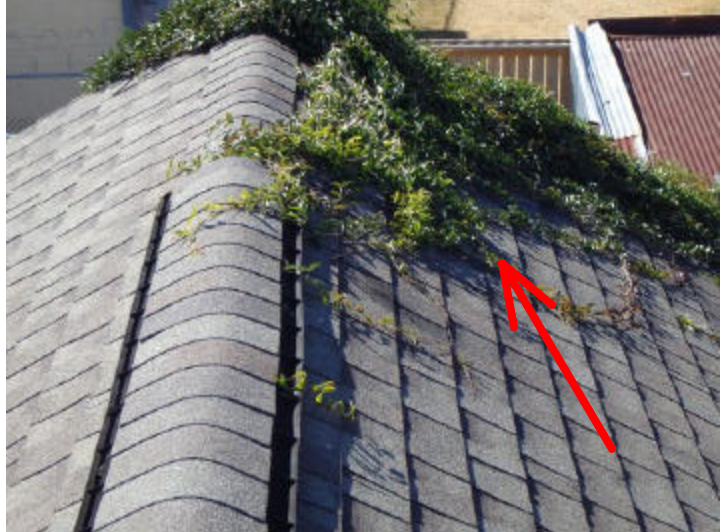
The vines noted on the roof should be removed to minimize damage potential.

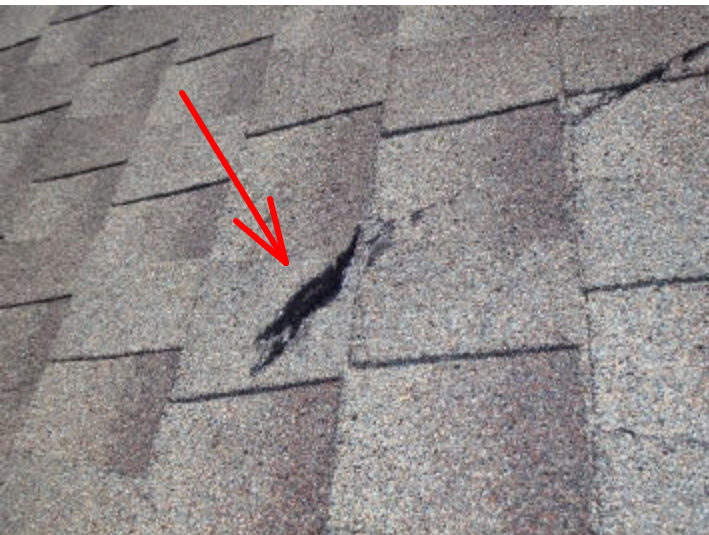
Damages were noted to the main roof at the left rear.

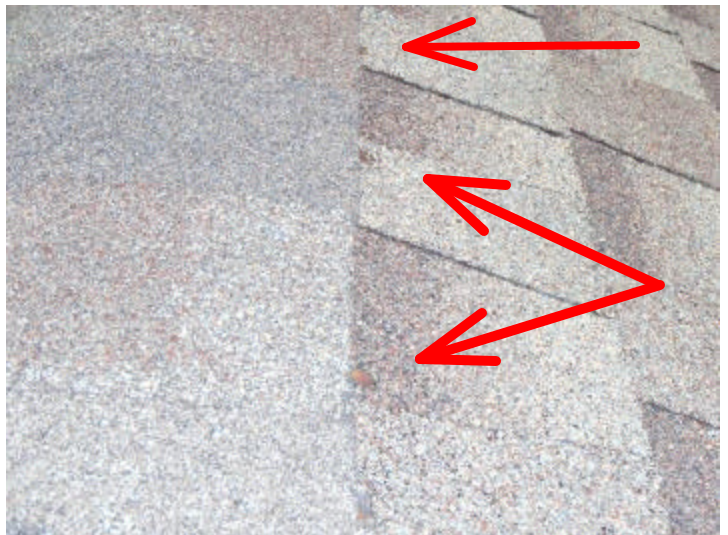
Exposed and rusted nail heads were noted on the top course behind the chimney. These nail heads should be sealed to prevent further rust and potential leaks.

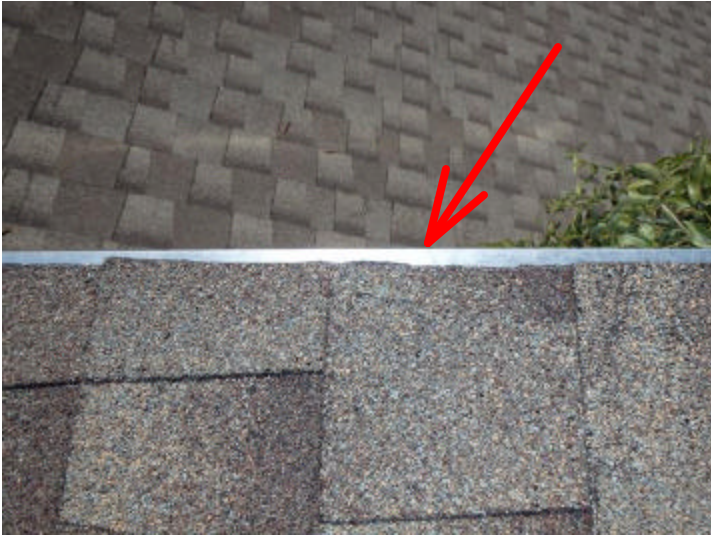
The shingles on the rear of the main roof do not overhang enough, which can cause water to roll back and penetrate the roof sheathing.

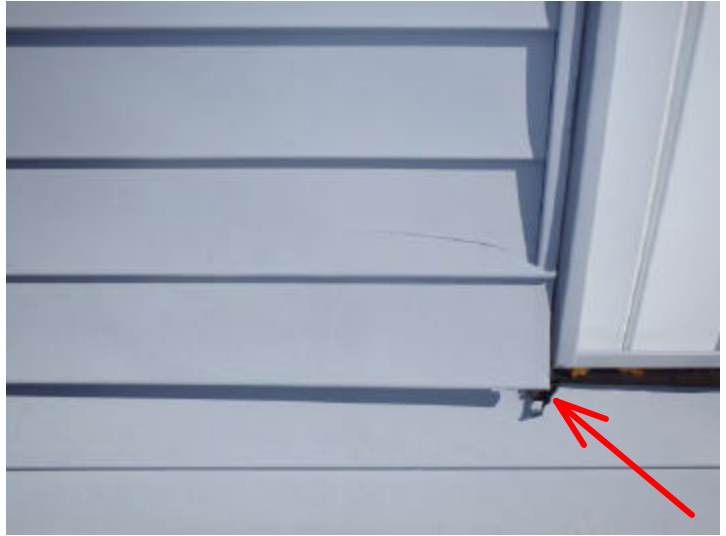
The siding is loose and wavy in various areas throughout.

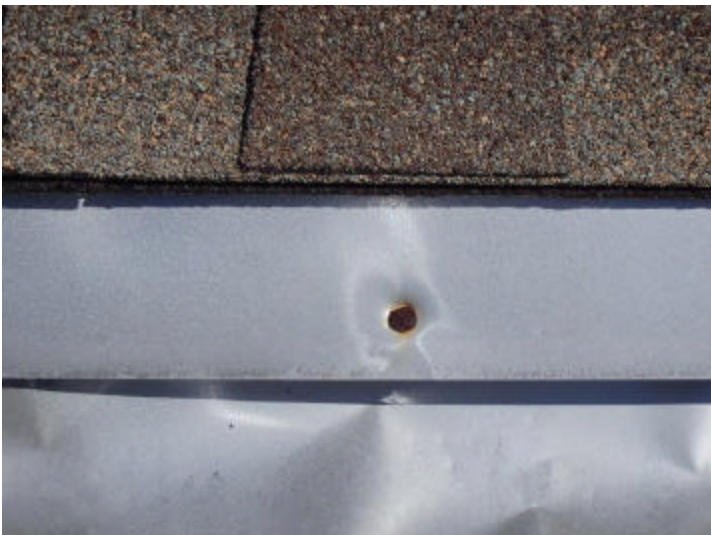
The flashing at the rear of the main house is loose and has exposed and rusted nails.

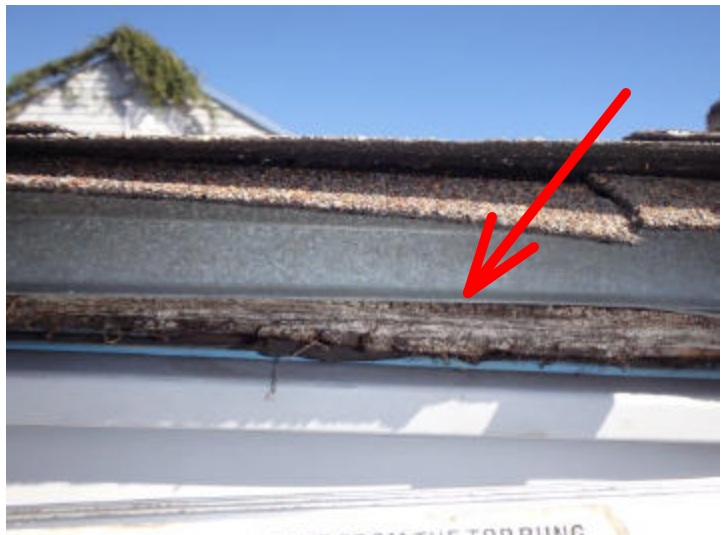
Exposed decking was noted at the rear by the shed type roof. This area should be properly sealed to prevent further moisture damages.

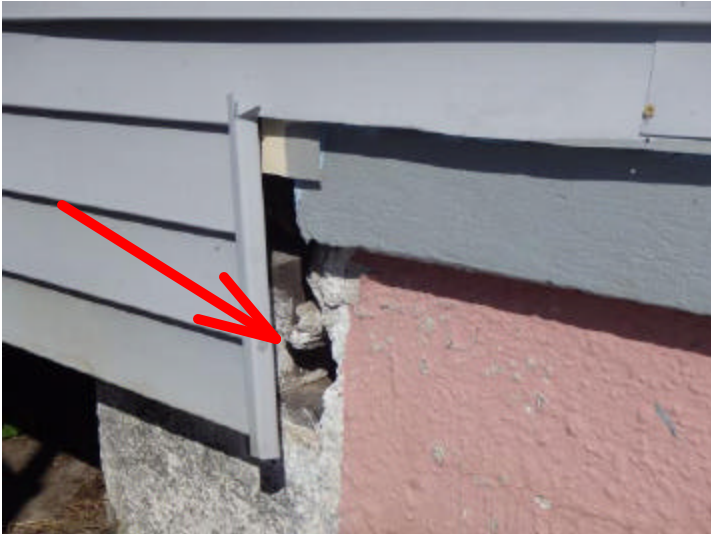
The siding at the rear should be properly sealed to prevent moisture intrusions.

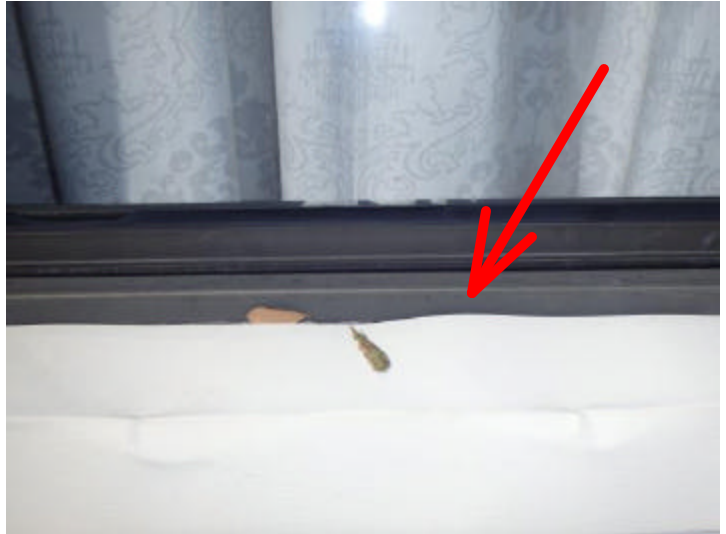
Some of the metal capping at the window sills is wavy and not caulked, which can cause moisture intrusions.

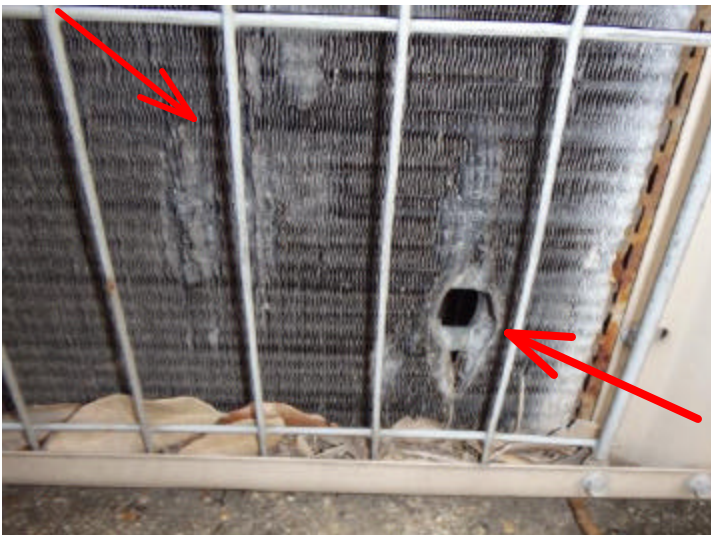
The fins of the condensing unit are damaged and have holes in them.

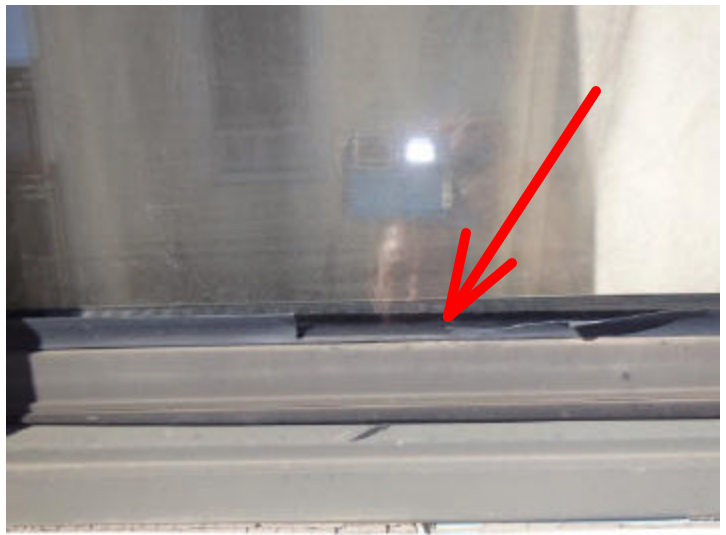
Some of the rubber strips, to secure the window panes to the frame, are cracked.

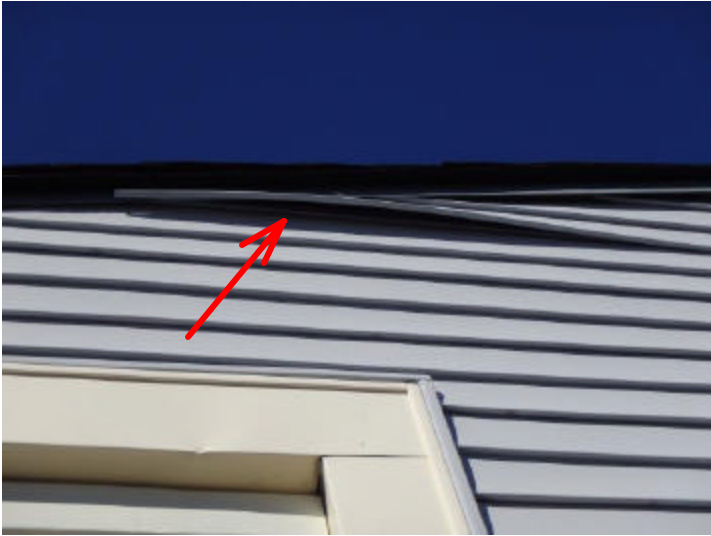
The siding is loose and wavy in various areas throughout.

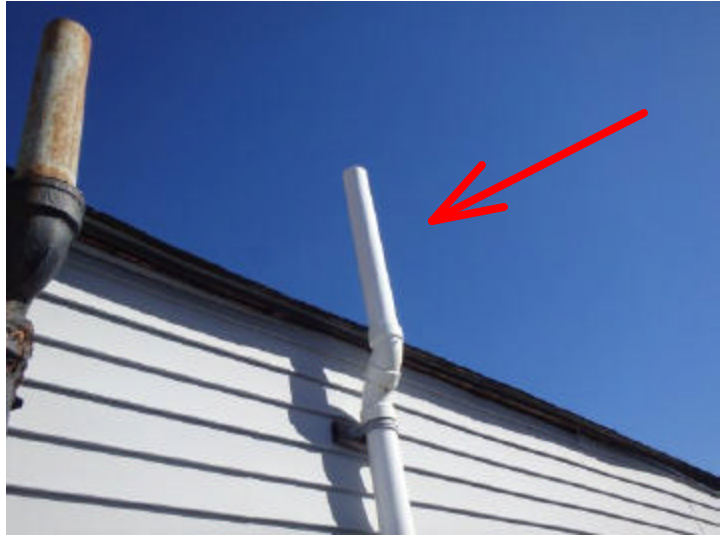
The plastic vent pipes should be painted to prevent damages from the sun's ultraviolet rays.

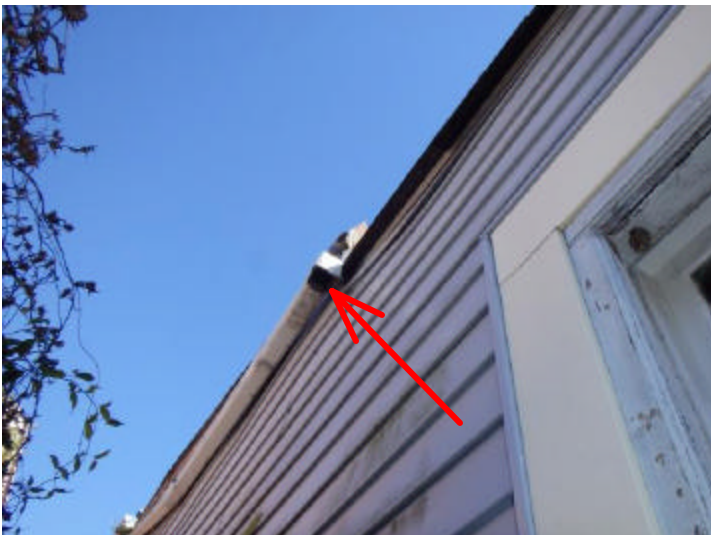
The right rear downspout is missing.

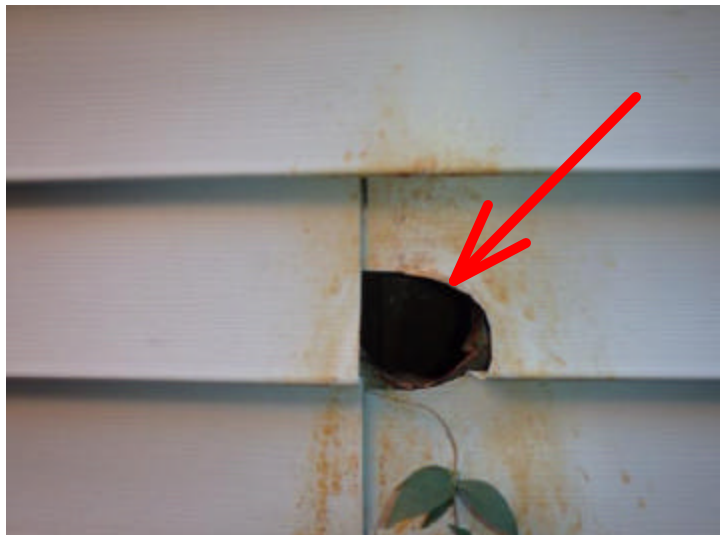
The penetration hole through the exterior siding on the right by the plumbing vent should be sealed to prevent moisture from entering the wall cavities.

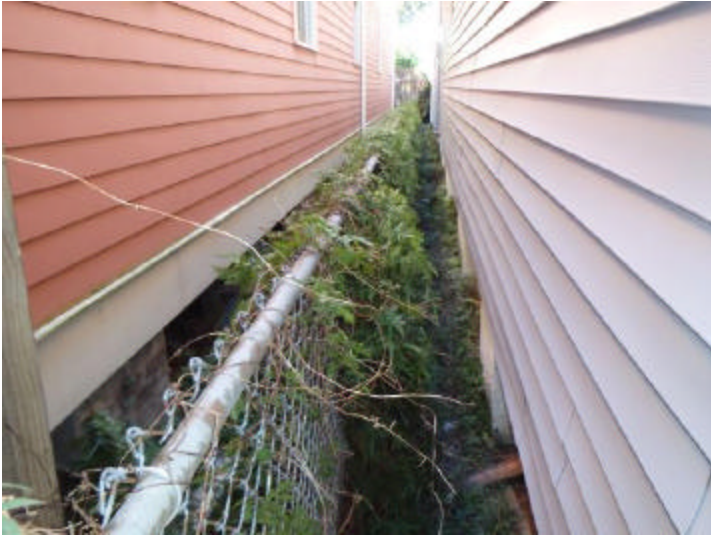
The vine growth on the rear of the house and the fence should be removed to minimize damage potential.

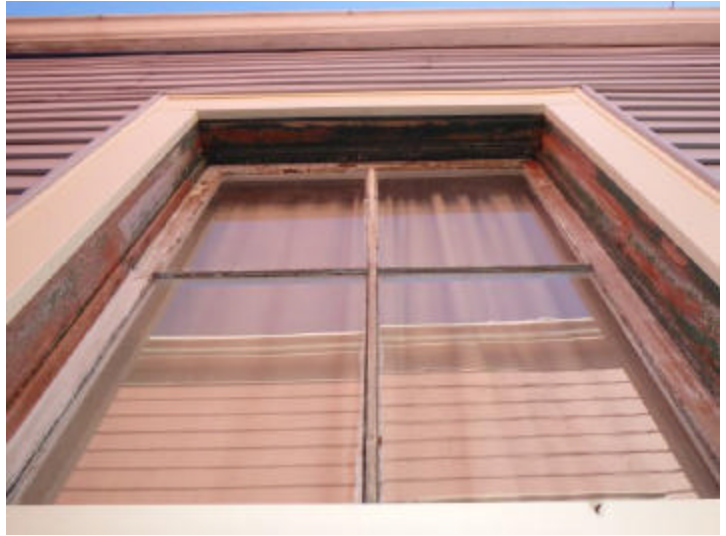
Some of the pane glazing has moderate age cracking and separations, which can cause the window panes to loosen.

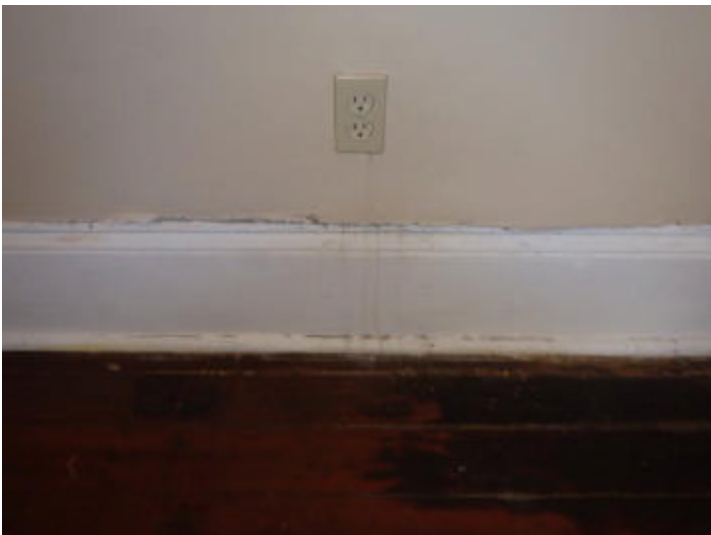
Moisture stains were noted on the floor and baseboard and a loose patch with water stains was noted on the right wall in the 4th bedroom. Damages to the underlying wood, if any, could not be evaluated, due to the finished walls. We recommend further evaluation to determine the source of the leak and repairing as necessary.

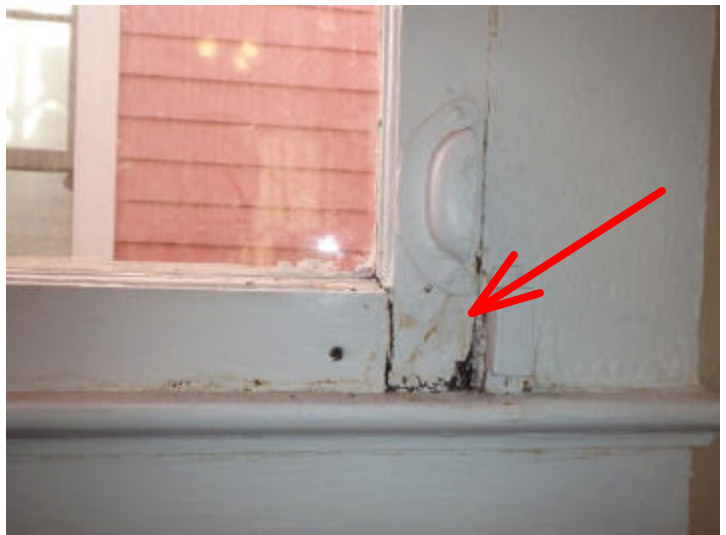
Water stains were noted on the insides of some of the wood windows from moisture penetrations. This condition could be the result of the heavy pane glaze cracking noted on the exterior. We recommend monitoring these stains and repairing as necessary.
